EXHIBIT A

PHOTO SHEETS

MURRIETA CREEK, FLOOD PROTECTION CORRIDOR PROGRAM APPLICATION

APPLICANT: RIVERSIDE COUNTY FLOOD CONTROL AND WATER CONSERVATION DISTRICT

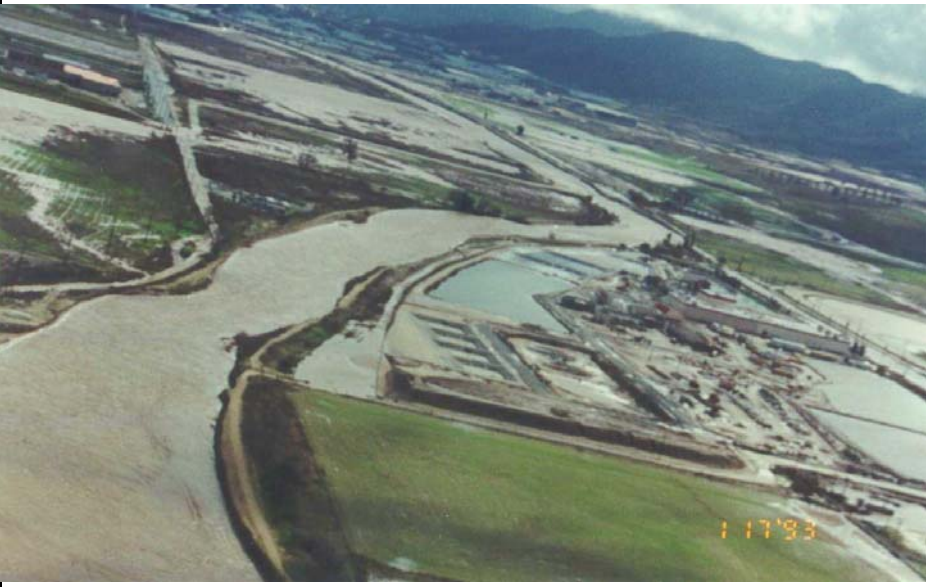
PHOTO ONE	COMMENTS

<p>AN AERIAL VIEW TAKEN IN JANUARY OF 1993.</p> <p>VIEW IS LOOKING D/S ALONG MURRIETA CREEK TOWARDS ELM STREET.</p> <p>THE FACILITY TO THE RIGHT IS A WATER RECLAMATION PLANT.</p> <p>THE CREEK HAS INUNDATED THE SURROUNDING AREA BY OVERTOPPING THE BANKS</p>
PHOTO TWO	COMMENTS

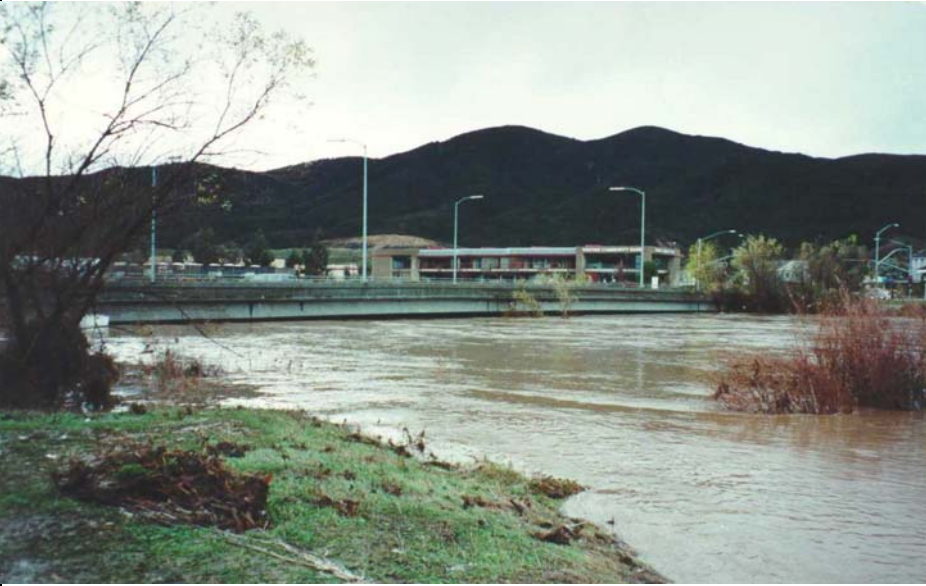
<p>JANUARY, 1993 LOOKING DOWNSTREAM AT THE RANCHO CALIFORNIA BOULEVARD BRIDGE.</p> <p>AT THE PEAK OF THE FLOODING, WATER FLOWED OVER THE ROADWAY AND APPROACHES TO THE BRIDGE.</p>

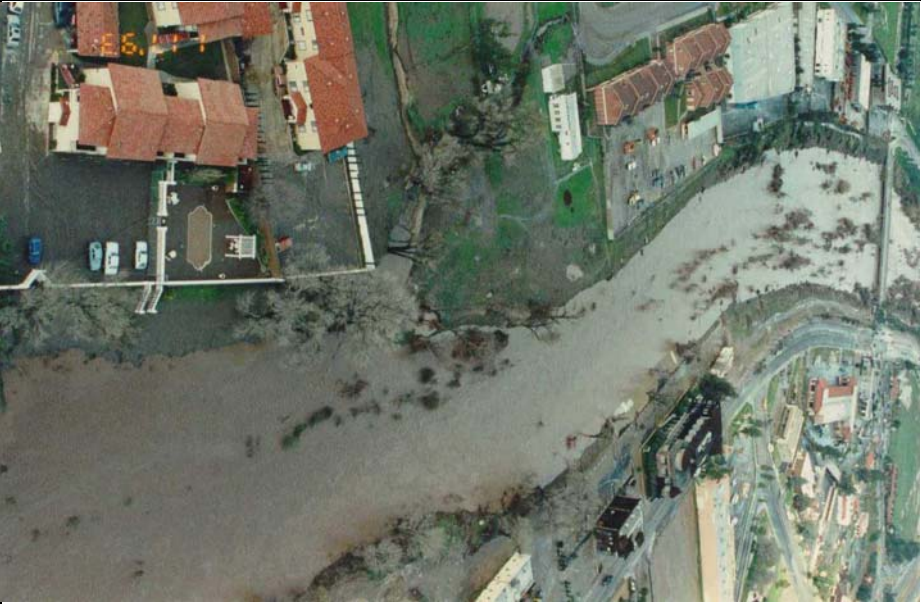
PHOTO THREE	COMMENTS

<p>AN AERIAL VIEW THROUGH OLD TOWNE TEMECULA</p> <p>THE GRANT PROJECT BEGINS AT THE APARTMENT IN THE UPPER LEFT AND CONTINUES DOWNSTREAM</p> <p>NOTE THE SWIMMING POOL FILLED WITH MUD</p> <p>PHOTO FROM JANUARY, '93</p>
PHOTO FOUR	COMMENTS

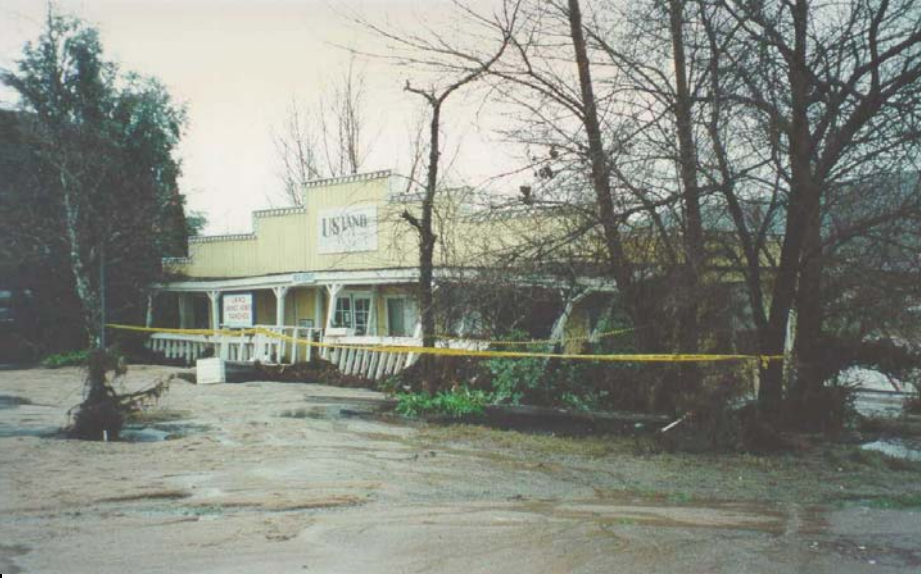
<p>FLOOD OF JANUARY 1993.</p> <p>MUDFLOW DAMAGE AT THE U.S. LAND COMPANY IN OLD TOWNE TEMECULA.</p> <p>6th AND FRONT STREET, EAST OF MURRIETA CREEK, JUST U/S OF FIRST PHASE</p>

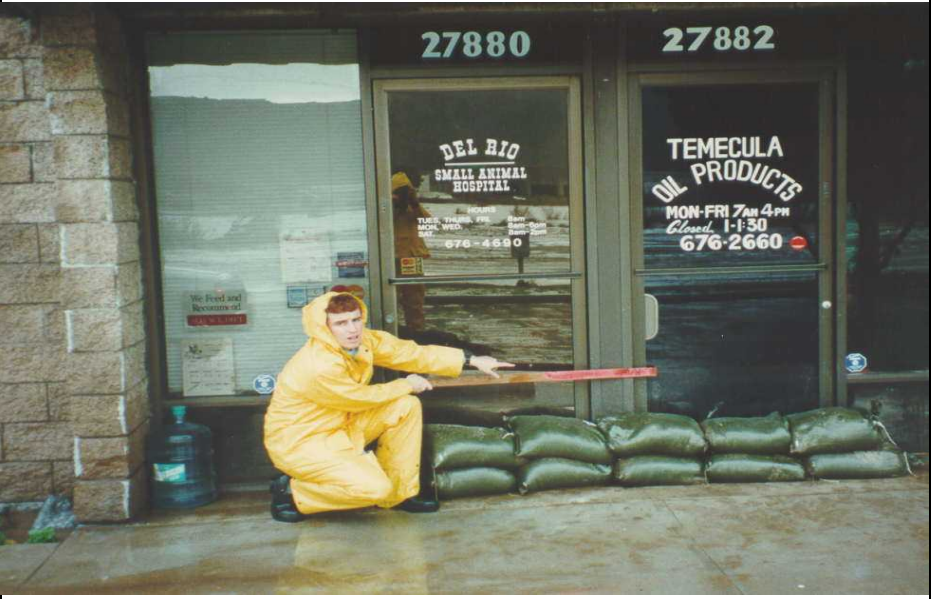
PHOTO FIVE	COMMENTS

JANUARY, 1993 4th STREET AND FRONT MARKER SHOWS LEVEL OF MUD INTRUSION
PHOTO SIX	COMMENTS

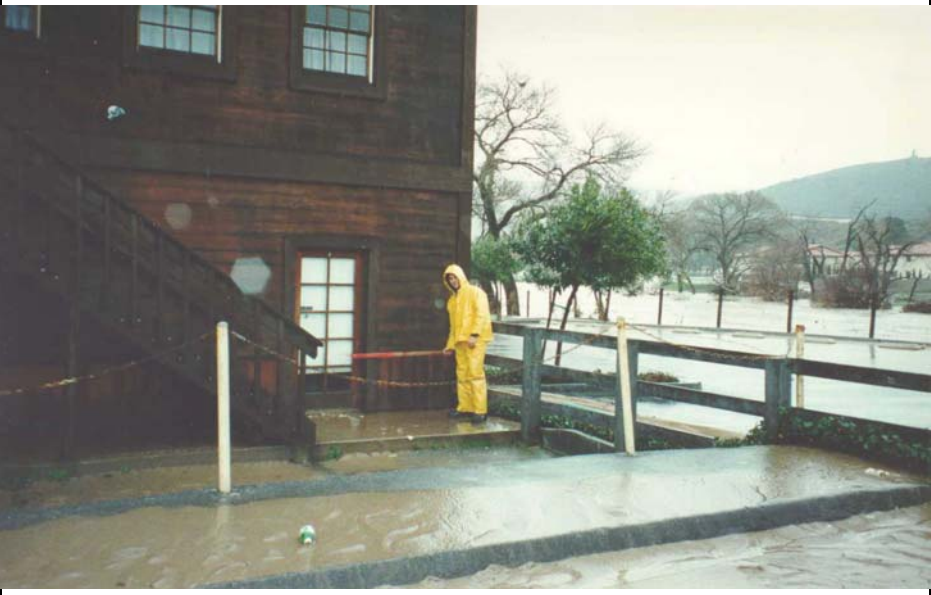
JANUARY, 1993 MORE FLOOD DAMAGE MURRIETA CREEK CAN BE SEEN IN THE BACKGROUND

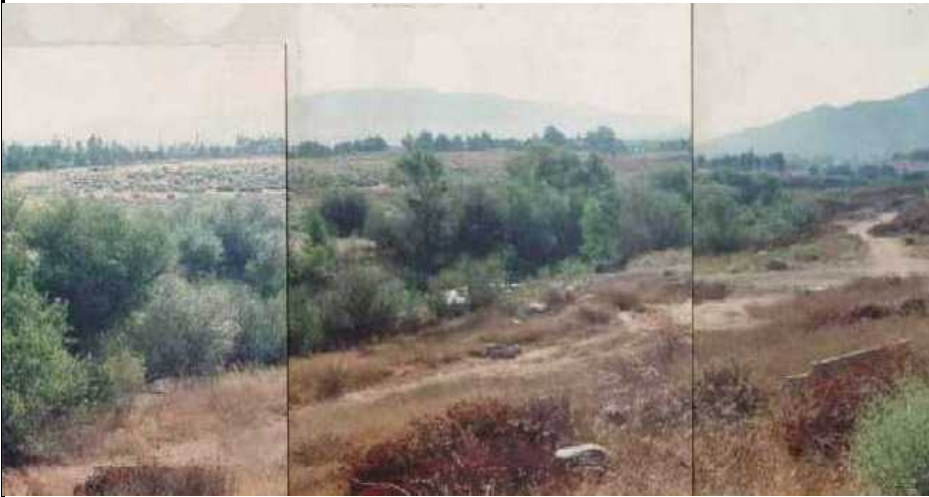
PHOTO SEVEN	COMMENTS

<p>DOWNSTREAM TERMINUS OF THE PROJECT.</p> <p>THIS SCENE WAS TAKEN PRIOR TO THE 1993 FLOODS</p> <p>COMPARE TO THE DAMAGE PHOTO #8 SHOWING THE</p> <p>SAME VIEW</p>
PHOTO EIGHT	COMMENTS

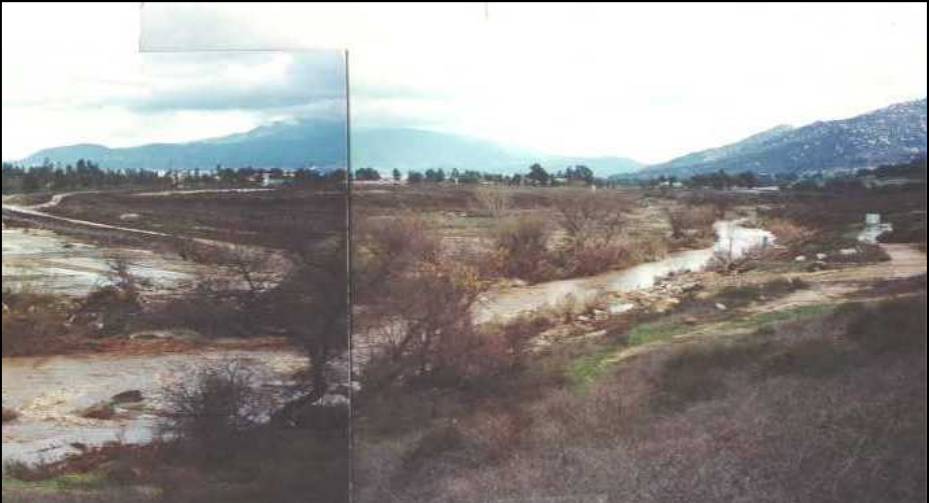
<p>JANUARY, 1993</p> <p>SAME VIEWPOINT AS #7 TAKEN IMMEDIATELY AFTER THE FLOODING.</p> <p>PICTURE #9 SHOWS SAME SCENE AFTER CLEANUP EFFORTS</p>

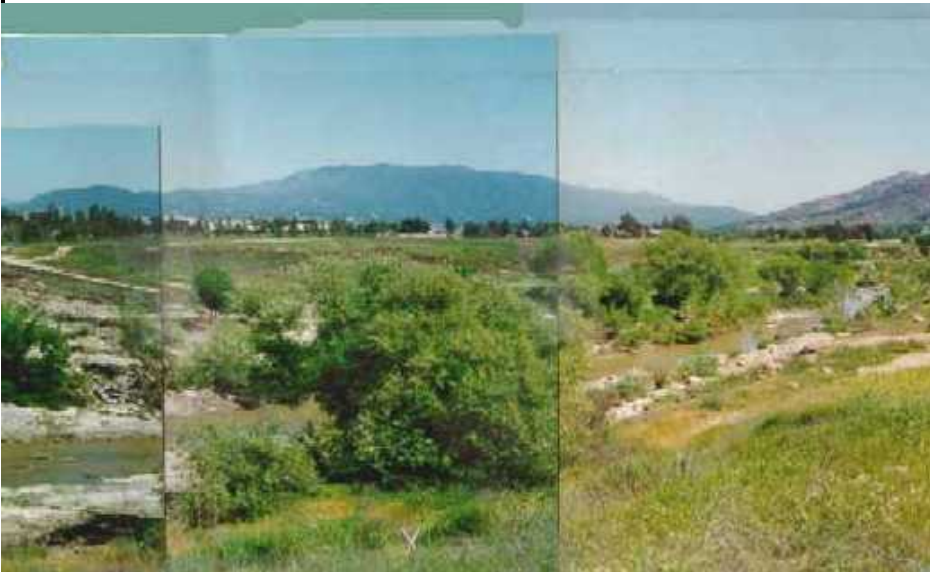
PHOTO NINE	COMMENTS

<p>SAME VIEW AS #7-8.</p> <p>THIS SCENE APPROX. ONE YEAR AFTER CLEANUP</p> <p>VEGETATION BEGINS TO RETURN</p>
PHOTO TEN	COMMENTS

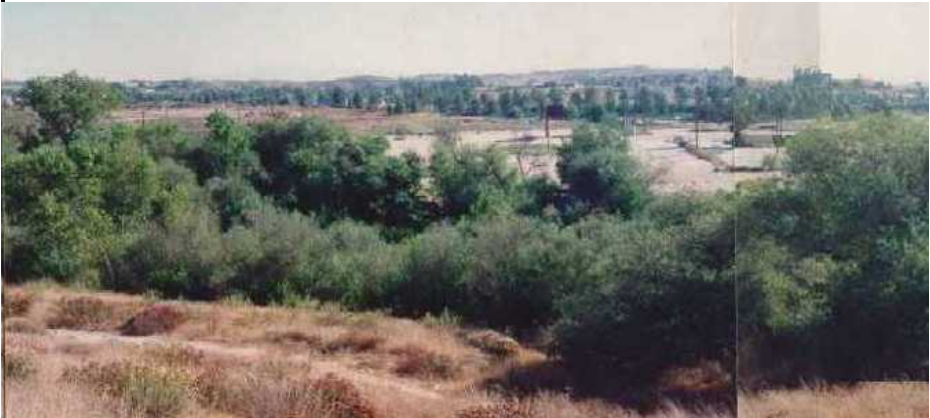
<p>PANORAMIC VIEW OF LOWER REACHES OF FIRST PHASE.</p> <p>TIME FRAME APPROX. 7-92 PRIOR TO 1993 FLOODING</p> <p>COMPARE TO THE FLOOD PICTURE BELOW (#11)</p>

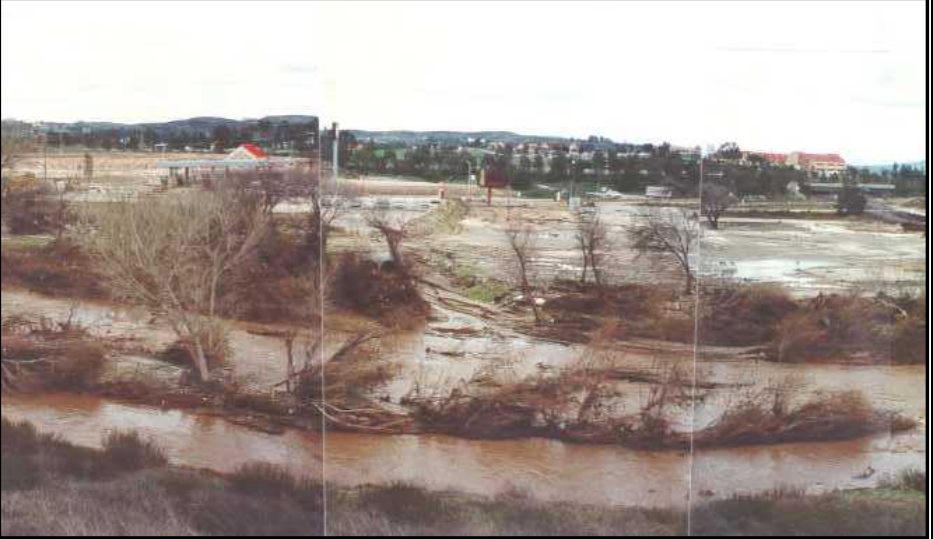
PHOTO ELEVEN	COMMENTS

JANUARY, 1993 FLOODING SAME VIEW AS PHOTO #10.
PHOTO TWELVE	COMMENTS

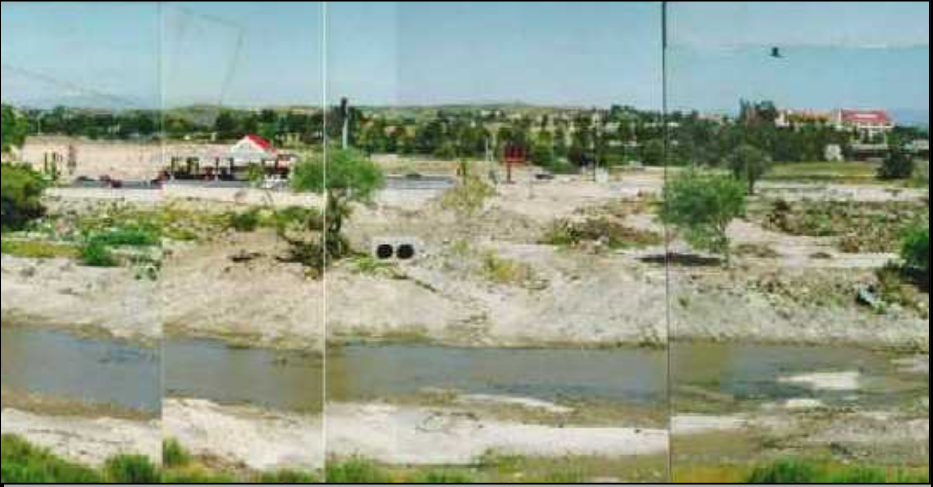
SAME VIEW AS #11 THIS SCENE APPROX. ONE YEAR AFTER CLEANUP

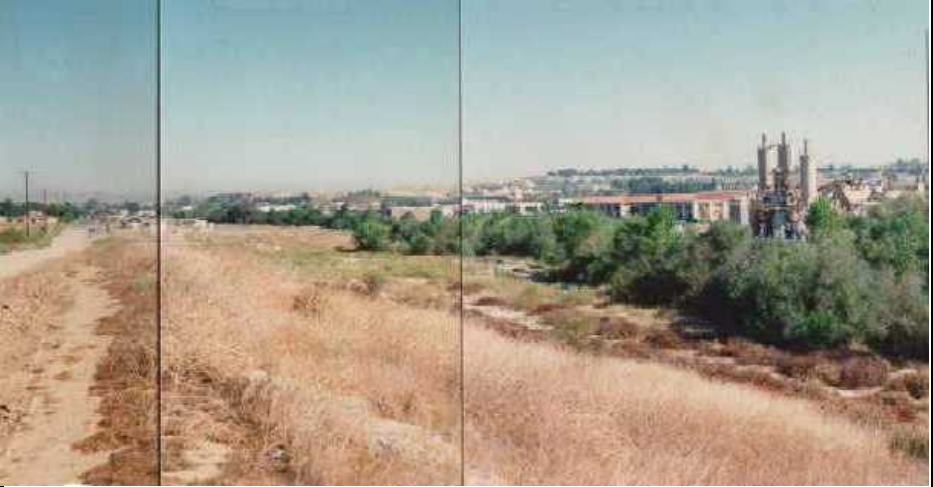
PHOTO THIRTEEN	COMMENTS

PRIOR TO FLOOD DAMAGES LOOKING UPSTREAM AT CONCRETE BATCH PLANT TOWARDS FIRST STREET AND U/S TERMINUS OF PROJECT
PHOTO FOURTEEN	COMMENTS

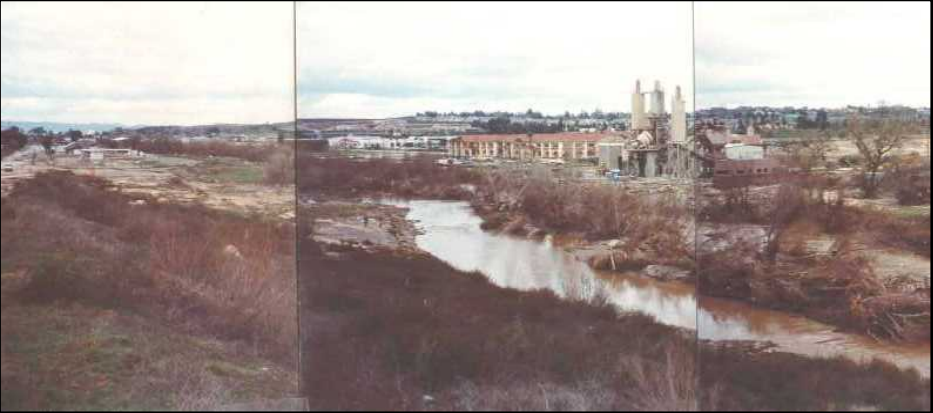
JANUARY, 1993 FLOODING SAME VIEW AS PHOTO #13.

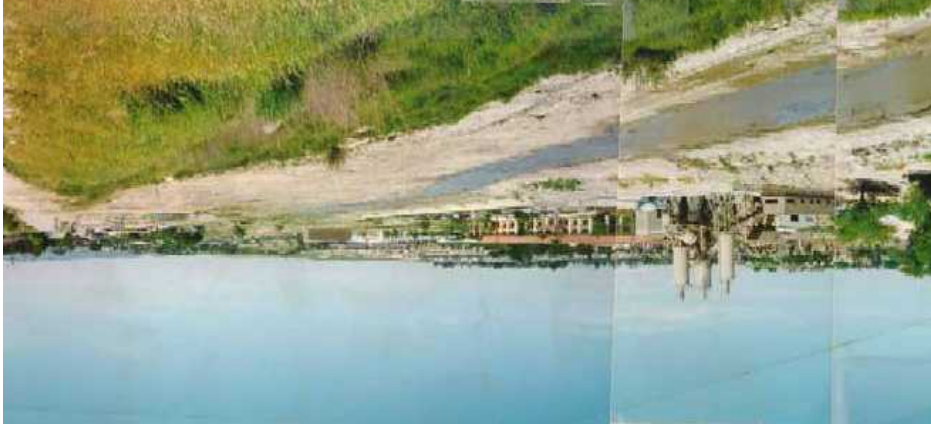
PHOTO FIFTEEN	COMMENTS

<p>SAME VIEW AS #14.</p> <p>TAKEN APPROXIMATELY ONE YEAR AFTER CLEANUP</p>
PHOTO SIXTEEN	COMMENTS

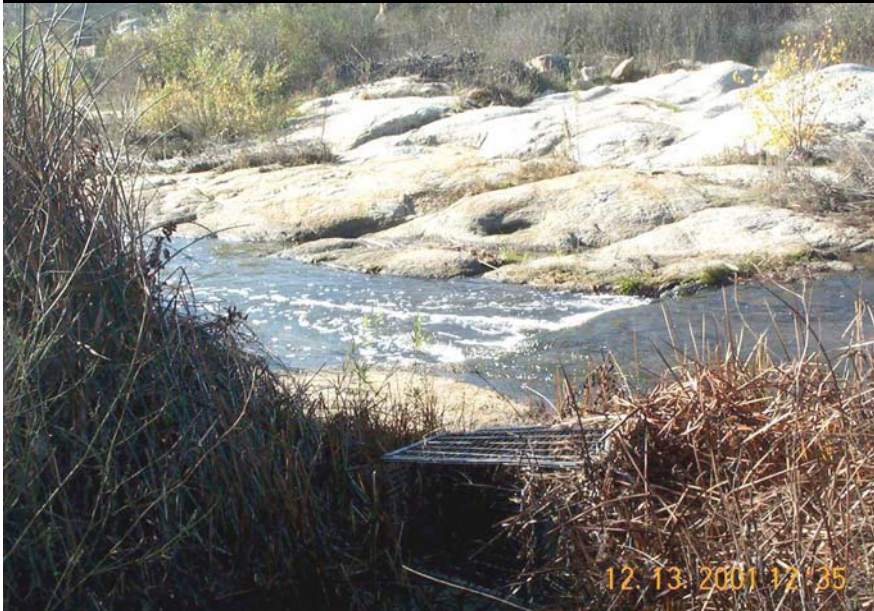
<p>DECEMBER, 2001</p> <p>LOOKING DOWNSTREAM TOWARDS THE GAGE STA. AND THE LOWER TERMINUS OF PROJECT.</p> <p>NOTE THE SCOURING OF THE INVERT TO BEDROCK.</p> <p>THE SHOPPING CART IN THE FOREGROUND IS TYPICAL OF URBAN STREAMS</p>

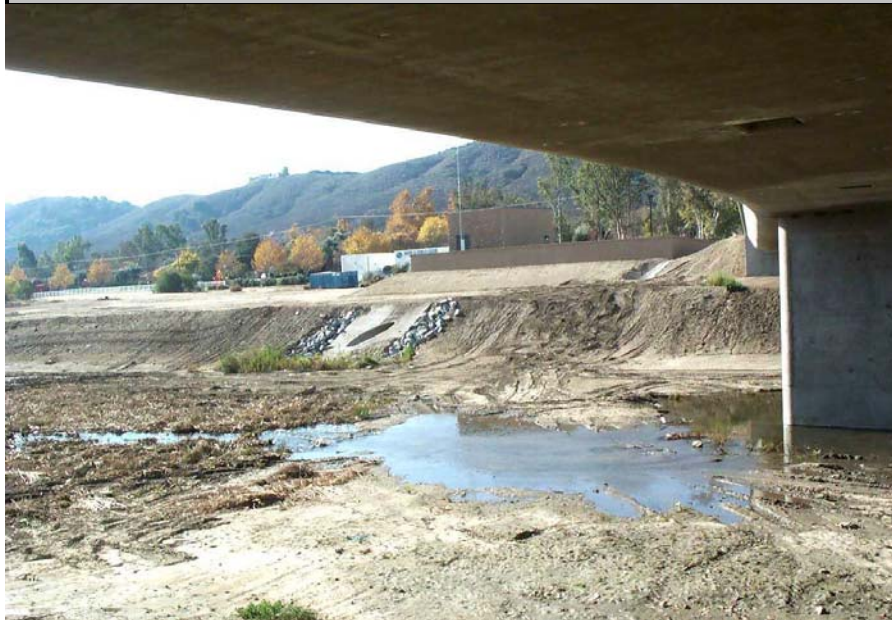
PHOTO SEVENTEEN	COMMENTS

<p>DECEMBER, 2001</p> <p>ON THE EAST B/ THE FIRST STREET BRIDGE.</p> <p>THE SEDIMENT DEPOSITION IS CLEARLY VISIBLE</p> <p>THIS IS THE U/S TERMINUS OF THE FIRST PHASE THIS REACH WILL BE PROTECTED BY GABIONS AS THE PROPERTY IS ALREADY DEVELOPED ON BOTH BANKS</p>
PHOTO EIGHTEEN	COMMENTS

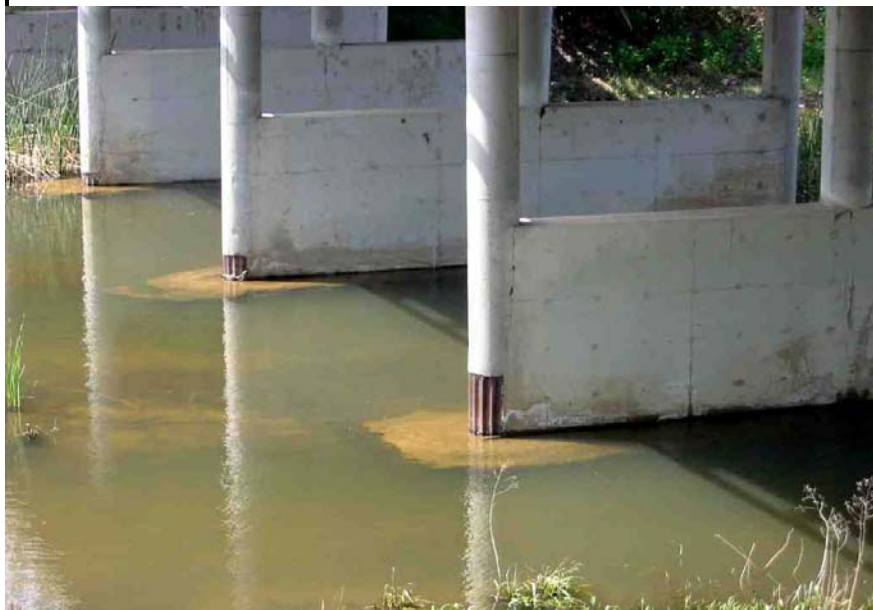
<p>DECEMBER, 2001</p> <p>JUST UPSTREAM FROM PRIOR PICTURE, MURRIETA CREEK HAS SCOURED THE INVERT.</p> <p>HERE THE FOUNDATIONS OF THE LEFT BANK RECEIVES SEDIMENT.</p>

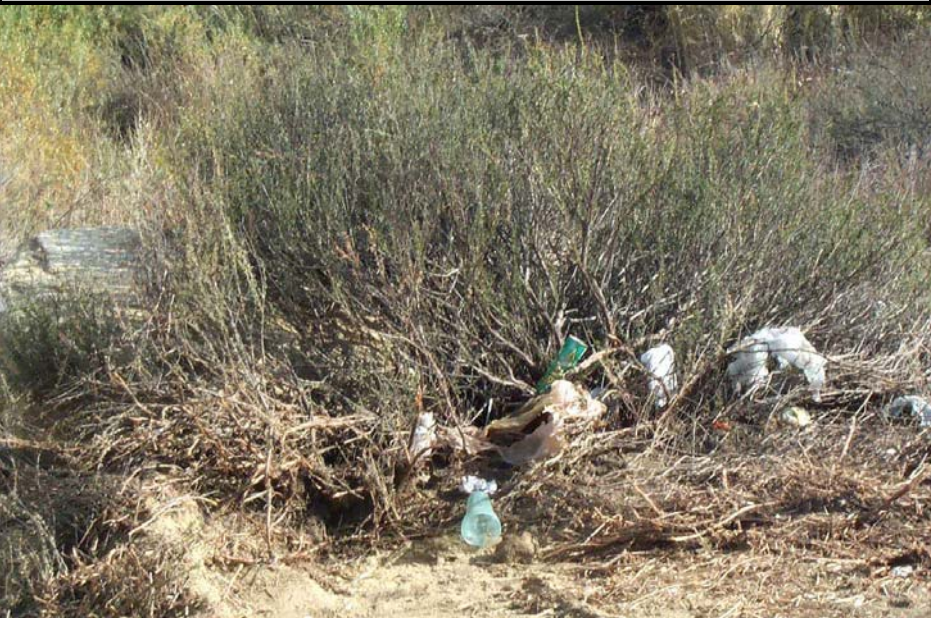
PHOTO NINETEEN	COMMENTS

A photograph showing a pile of dry brush and trash along a creek bank. The trash includes a green plastic bottle, a brown paper bag, and other debris. The background shows dense brush and a dirt path.	<p>DECEMBER, 2001</p> <p>TYPICAL TRASH DEPOSITS ALONG THE CREEK</p> <p>IN PARTNERSHIP WITH LOCAL STEWARDS, THE DISTRICT WILL SPONSOR CLEAN UP EFFORTS ALONG THE CREEK AND NEW TRAILSTO BE BUILT ALONG THE BANKS</p>
PHOTO TWENTY	COMMENTS

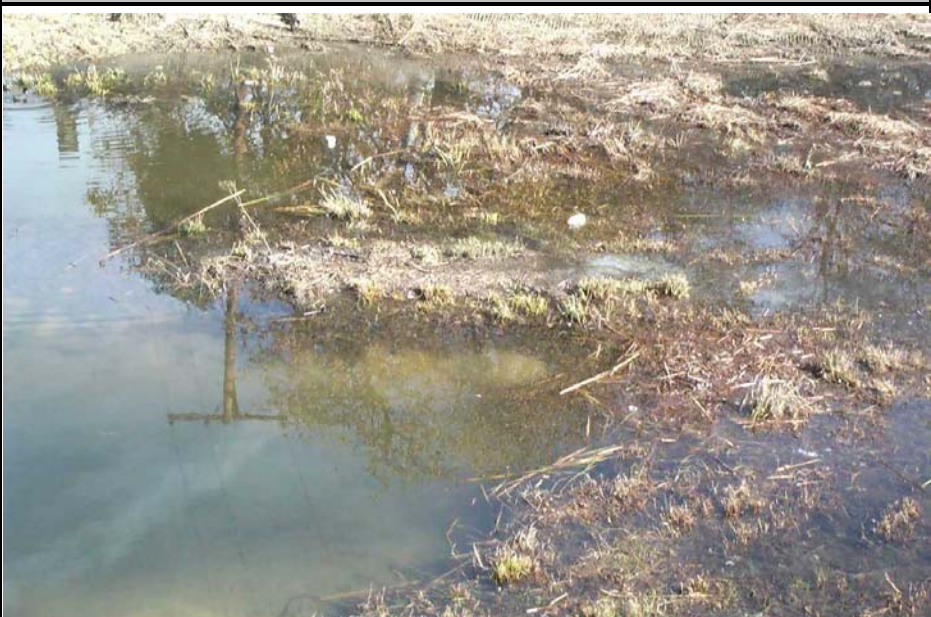
A photograph showing trash deposits in a creek stream. The water is murky, and there is a lot of debris, including bottles and plastic refuse, visible in the stream. The background shows a dirt bank and some vegetation.	<p>DECEMBER, 2001</p> <p>TYPICAL TRASH DEPOSITS ALONG THE CREEK BOTTLES AND PLASTIC REFUSE VISIBLE IN STREAM</p> <p>IN PARTNERSHIP WITH LOCAL STEWARDS, THE DISTRICT WILL SPONSOR CLEAN UP EFFORTS ALONG THE CREEK AND NEW TRAILSTO BE BUILT ALONG THE BANKS</p>

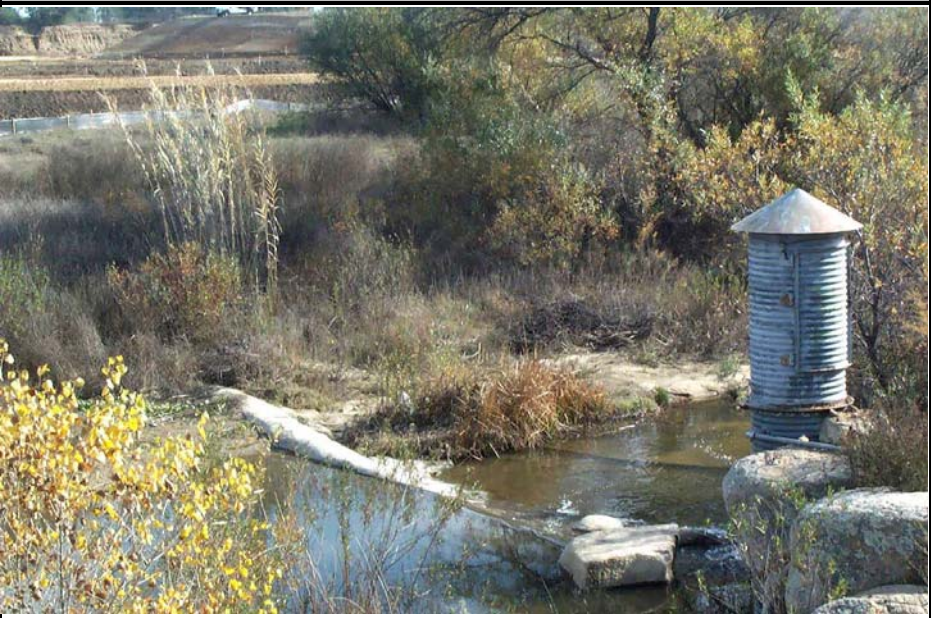
PHOTO TWENTY-ONE	COMMENTS

<p>DECEMBER, 2001</p> <p>ANOTHER BENEFIT OF THE PROJECT WILL BE THE ELIMINATION OF NON-NATIVE PLANTS COMPETING WITH LOCAL VEGETATION.</p> <p>THIS VIEW SHOWS ARUNDO TAKING HOLD AT THE GAGE STATION, D/S TERMINUS OF THE FIRST PHASE</p>
PHOTO TWENTY-TWO	COMMENTS

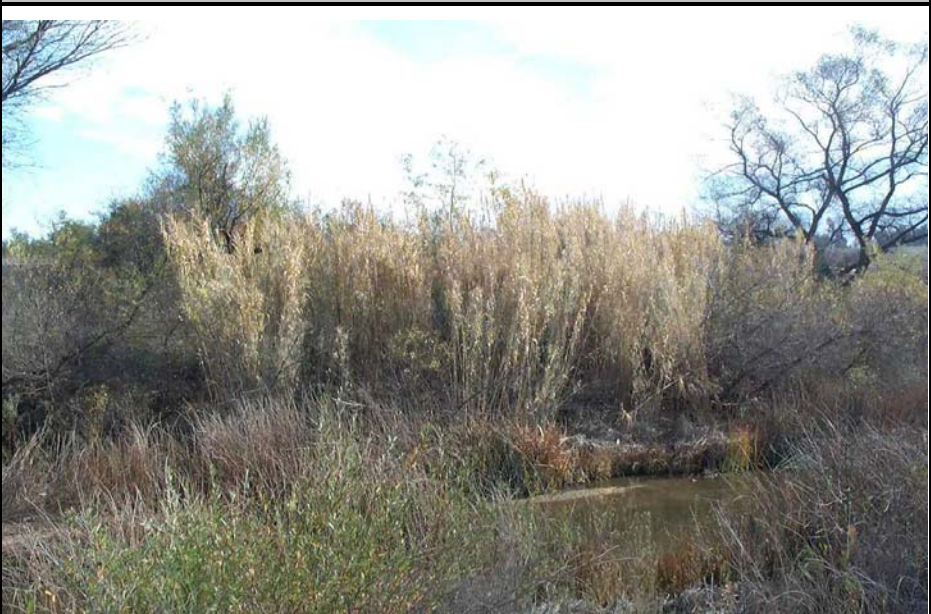
<p>DECEMBER, 2001</p> <p>MORE ARUNDO TAKING HOLD IN THE DOWNSTREAM REACH OF THE FIRST PHASE</p>

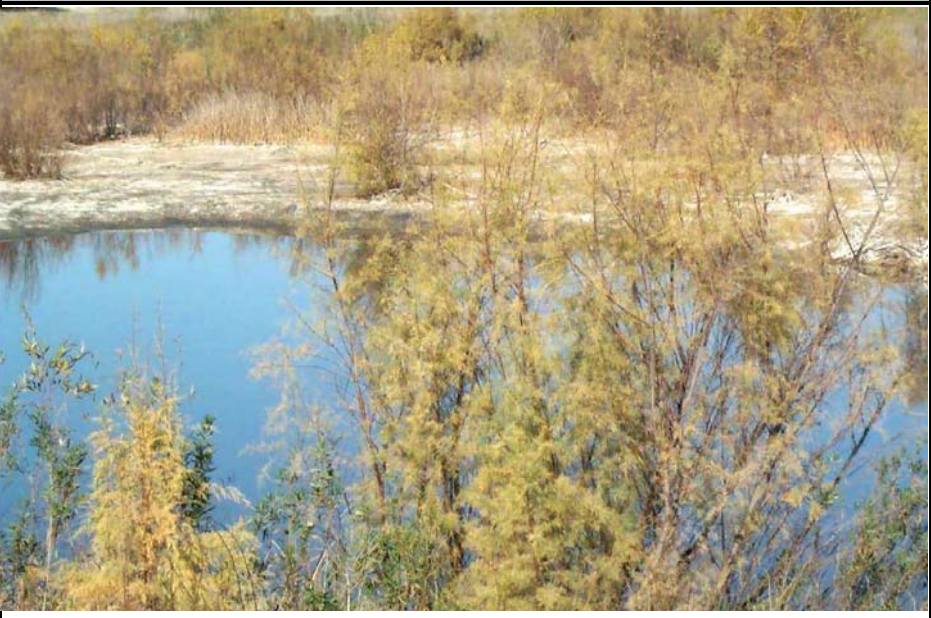
PHOTO TWENTY-THREE	COMMENTS

<p>DECEMBER, 2001</p> <p>THROUGHOUT MURRIETA CREEK, TAMARISK IS RAMPANT.</p> <p>CONSTRUCTION AND THE DISTRICT'S ONGOING PARTNERSHIP WITH THE LOCAL CITIZENS' GROUPS WILL KEEP ARUNDO AND TAMARISK UNDER CONTROL</p>
PHOTO TWENTY-FOUR	COMMENTS

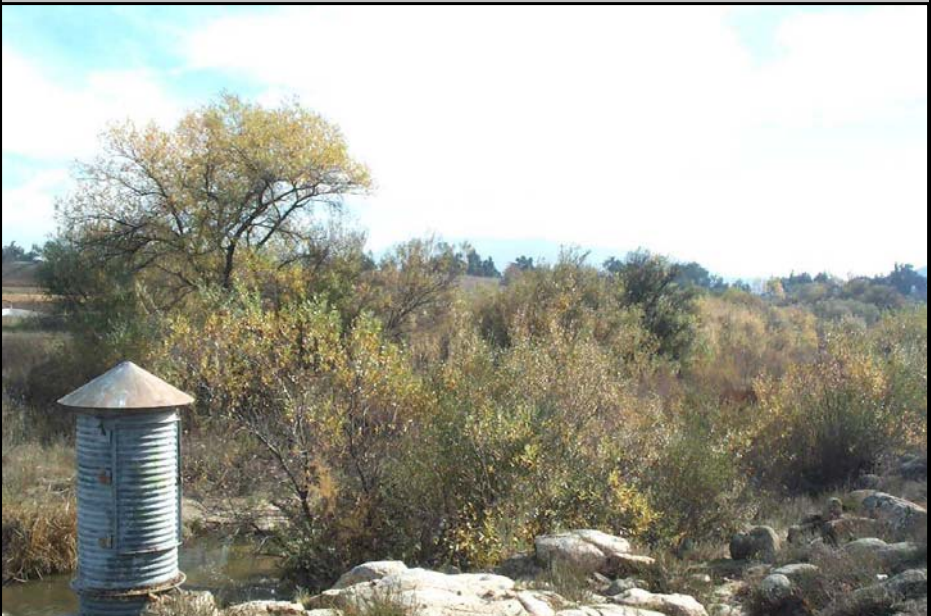
<p>DECEMBER, 2001</p> <p>BELOW THE GAGE STATION MURRIETA CREEK JOINS TEMECULA CREEK TO FORM THE SANTA MARGARITA RIVER</p> <p>JUST BELOW THIS SCENE IS THE 'GORGE', A WILDLIFE SANCTUARY.</p> <p>THE BEGINNING OF THE GORGE IS REGAINING ITS NATURAL STATE NINE YEARS AFTER THE FLOODING OF 1993. SEE PHOTO #8 TAKEN ABOUT 300 YDS U/S OF THIS SCENE</p>

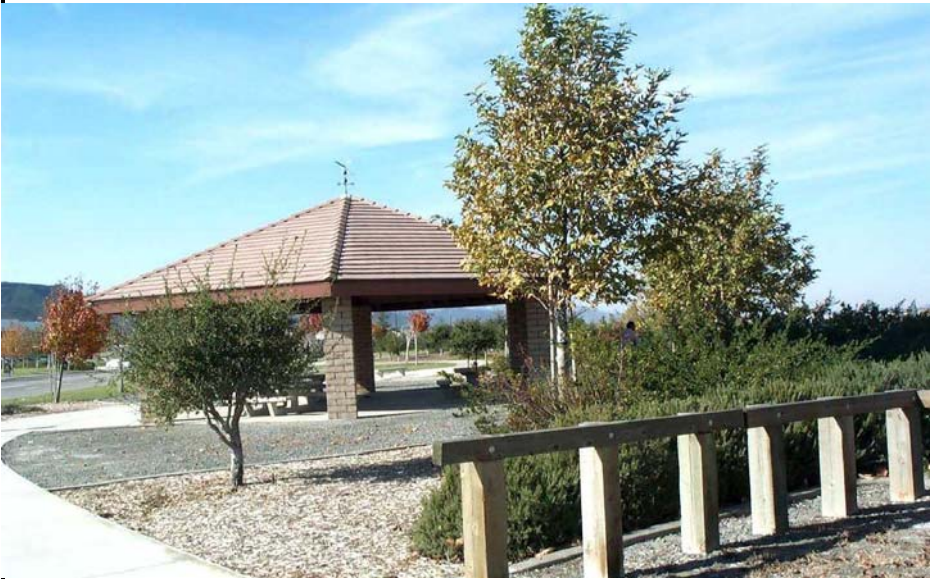
PHOTO TWENTY-FIVE	COMMENTS

<p>DECEMBER, 2001</p> <p>THE FIRST OF S POCKET PARKS' TO BE BUILT ALONG MURRIETA CREEK.</p> <p>ALL WILL BE CONNECTED BY BIKE, HIKING OR EQUESTRIAN TRAILS THAT PASS UNDER STREETS</p>
PHOTO TWENTY-SIX	COMMENTS

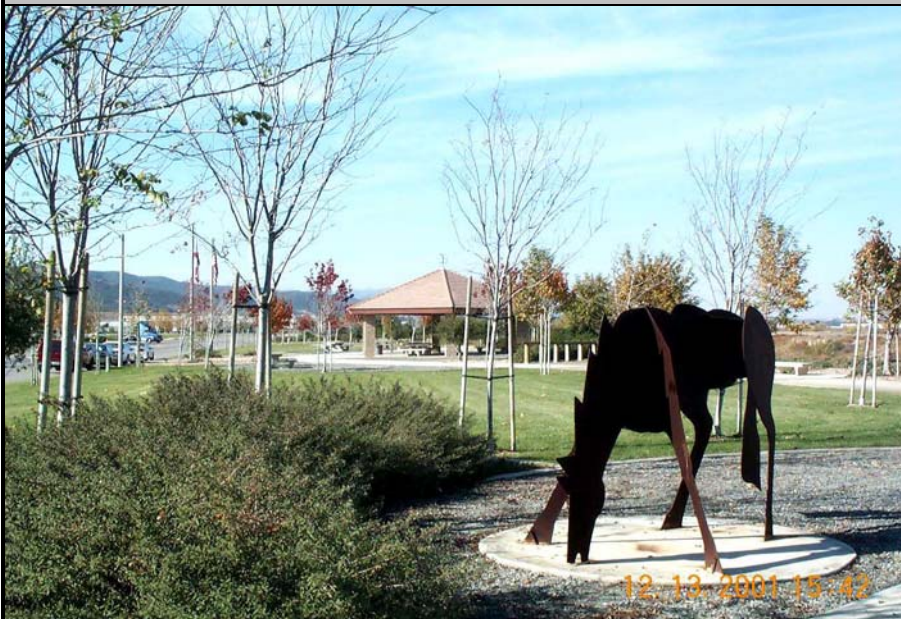
<p>DECEMBER, 2001</p> <p>ANOTHER VIEW OF THE PARK IN #25. THIS IS AN EQUESTRIAN PARK WITH PARKING FOR HORSE TRAILERS ALONG DIAZ ROAD</p> <p>THE 'POCKET PARKS' ARE BUT A SINGLE CONCEPT FOR RECREATION AND PUBLIC ACCESS. UPSTREAM A SPORTS PARK OF ABOUT 120 ACRES IS PLANNED AND WILL BE CONTAINED IN A SEDIMENTATION BASIN.</p>

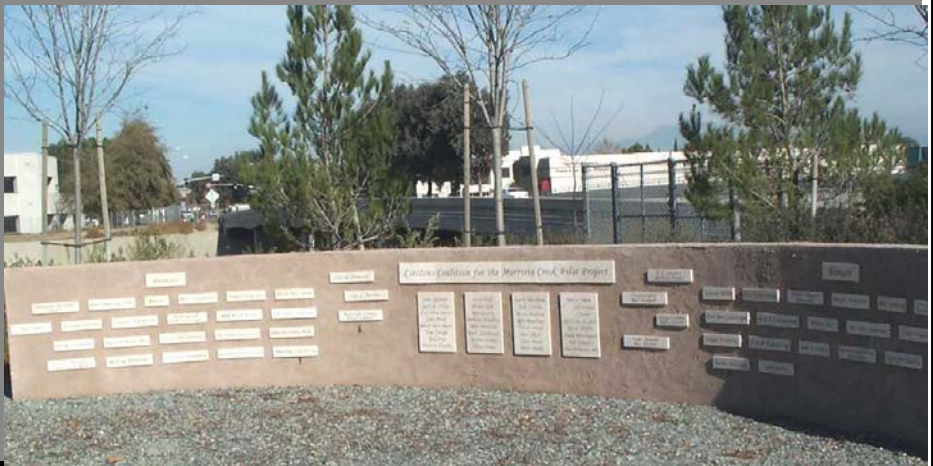
PHOTO TWENTY-SEVEN	COMMENTS

<p>DECEMBER, 2001</p> <p>THE PARK IN PHOTOS 25-26 WERE CONSTRUCTED IN COOPERATION WITH A LOCAL CITIZENS' GROUP</p> <p>SUCH PARKS GARNER WIDE SUPPORT IN THE COMMUNITY</p>
PHOTO TWENTY-EIGHT	COMMENTS

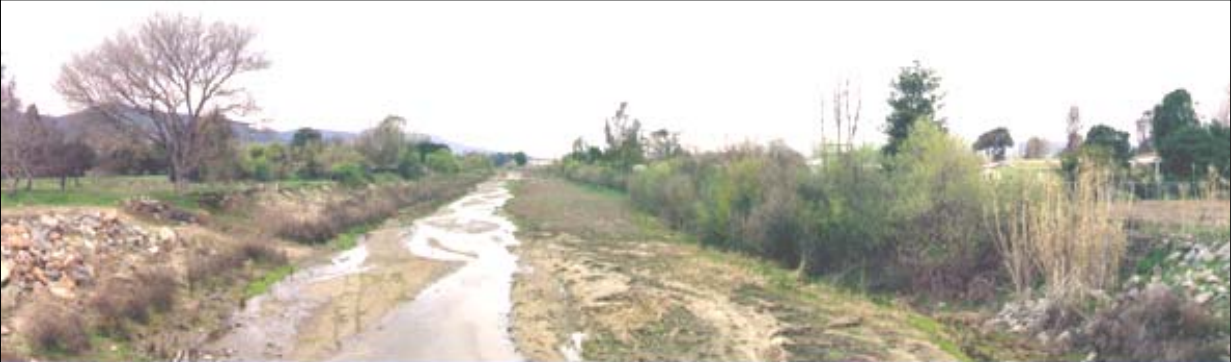
<p>EXISTING CONDITIONS ALONG THE UPPER REACHES OF MURRIETA CREEK</p>

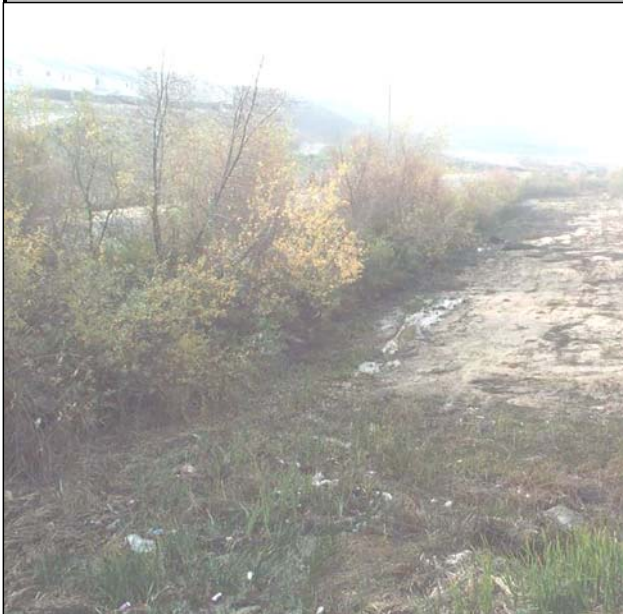
AN EXAMPLE OF A HABITAT CORRIDOR ON ONE OF THE DISTRICT'S FACILITIES

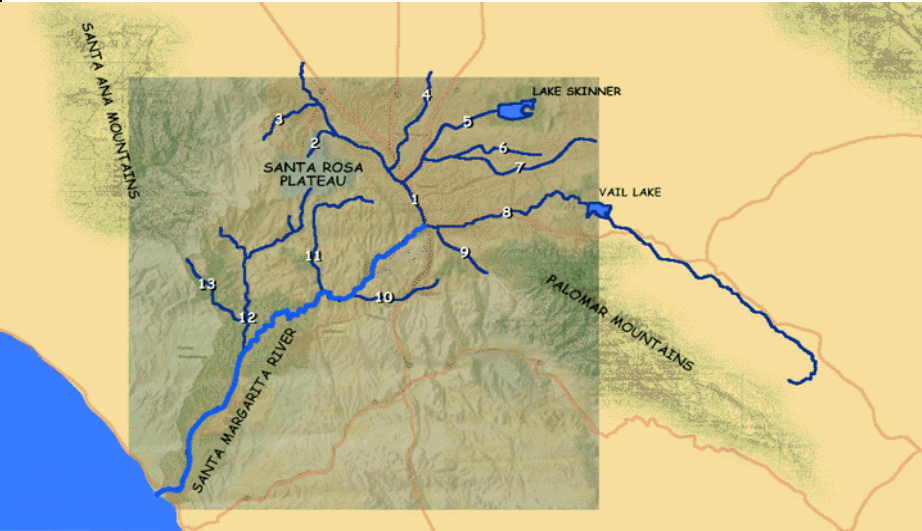
<p>THE WATERSHED OF THE SANTA MARGARITA RIVER</p> <p>NUMBER 1 REPRESENTS MURRIETA CREEK. THE PROJECT SITE IS ABOVE THE CONFLUENCE WITH #8, TEMECULA CREEK.</p>
